PRESERVATION OF HISTORICAL BRIDGES IN USA: THE GOLDEN GATE BRIDGE AND THE ALBION RIVER BRIDGE CASES

Keywords: Golden Gate Bridge; Albion River Bridge; Experimental testing; Seismic retrofit; Steel bridges; Timber bridges.

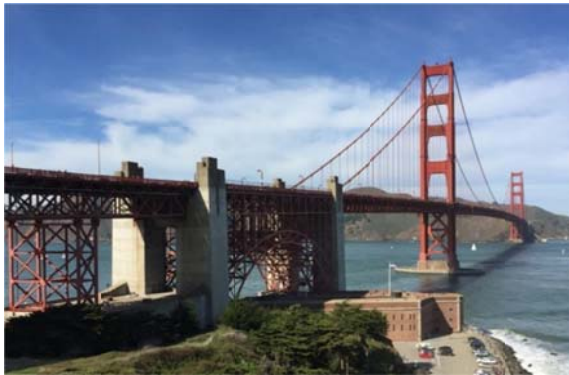
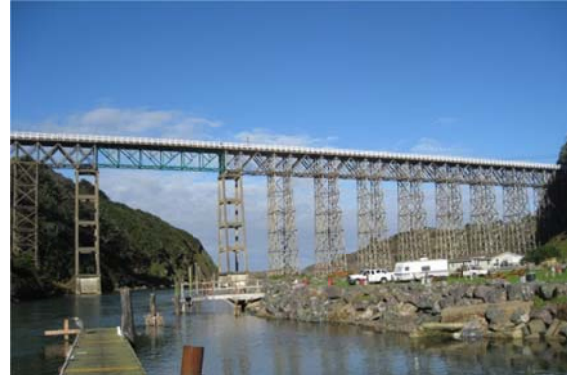
Figure 1: (a) the Golden Gate Bridge, and (b) the Albion River Bridge

Currently, there are 95214 assets such as sites, buildings, bridges, and other properties listed as U.S. National Historic Places, 2670 of them being bridges. The Golden Gate Bridge, Figure 1(a), a major steel suspension bridge, is currently eligible for the National Register of Historic Places in U.S. However, the bridge is a privately owned structure owned by the Golden Gate Bridge Highway and Transportation District and the owner had not applied for historical registration. The recreational area around the Golden Gate Bridge, which includes the historical Civil War era Point Fort, which is now located under the Golden Gate Bridge, is registered as a National Historic Place and is considered a U.S. Landmark. Due to historical and engineering significance of the Golden Gate Bridge, one of the marvels of bridge engineering, the case of historical preservation of this bridge is included in this paper.

One of the bridges that were just registered as a U.S. National Historic Place is the Albion River Bridge also discussed in this paper. The Albion River Bridge, Figure 1(b), is primarily a timber truss structure with timber braced towers. The main river crossing consists of two steel riveted trusses supported on two 4-legged concrete moment framed towers. The bridge is the last remaining well-engineered timber bridge in California, and maybe in the U.S.

Even before the design of the Golden Gate Bridge started, historical preservation was a major consideration. The alignment of the bridge was passing over the Fort Point, which is a fort built before the Civil War between 1853 and 1861, more than 70 years before the construction of the Golden Gate Bridge started. Currently, the Fort Point is a U.S. National Historic Landmark. At the time of design of the Golden Gate Bridge, an arch bridge was designed over the Fort Point, Figure 1(a), to cross over the historical building.

The Golden Gate Bridge, shown in Figure 1(b) on the previous page, consists of three distinct segments: the San Francisco approach structures, the Marin approach structure and the main suspension bridge. The two main towers of the suspension spans consist of two multi-cell steel tower legs connected to each other by horizontal trusses above the deck and cross bracings below the deck. The cross-section of the towers is formed with 1 meter (3-1/2 ft) square cells and the base of each leg is 15 cells long and nine cells wide. The cell walls at the base of the tower are 22mm (7/8 inch) thick silicon steel plates. As the tower approaches the top, the cross-section is reduced by reducing the number of cells until only 21 cells remain at the top. At the top of the towers, the suspension cables pass through a cable groove on the saddle. The cables are tied down to the concrete pylons at each end and are connected to the anchorages. The suspended bridge is connected to the shore by two approach structures. The Marin approach has a series of five 53.4-meter (175 ft.) deck truss spans supported on high, four-legged steel towers. The San Francisco approach has one two-hinged arch over the historical fort, two 38.1-meter (125 ft.) deck truss spans supported on two steel towers, one 53.4-meter (175 ft) deck span, and three 21.7-meter (71 ft.) plate girder spans.

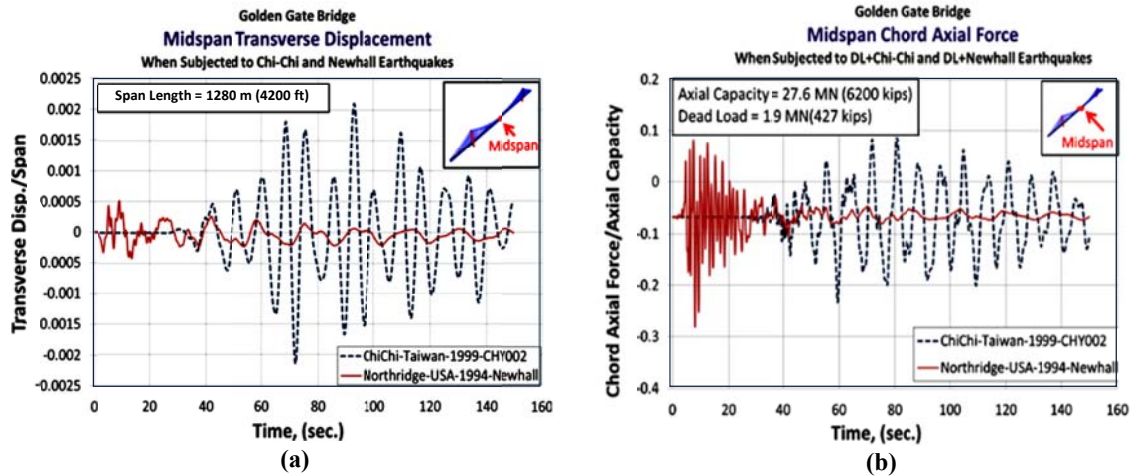
Figure 4: (a) The displacement response, and (b) the force response of the Golden Gate Bridge to Northridge and Chi-Chi ground motions [5]

Figure 4 shows the response of the Golden Gate Bridge to the strong but short period quake (Northridge –Newhall) and the weak but long-period earthquake (Chi-Chi-002). The left plot shows that the transverse displacement of the bridge midspan, when subjected to the weak Chi-Chi earthquake, is about four times the displacement generated by the much stronger Northridge earthquake ground motions. The larger displacement due to Chi-Chi earthquake indicates that this relatively weak earthquake, with an MPGA of 0.08g, can cause far more damage in the bridge especially in the expansion joints than what the much stronger Northridge earthquake, with MPGA of 0.60g can cause. The time-history plot on the right side of Figure 4 shows the axial force generated in the truss chord at midspan. The much weaker Chi-Chi quake creates almost the same axial force in the chords as the much stronger Northridge earthquake. The study of the Golden Gate Bridge [5] and other long-span bridges indicated that in design and evaluation of these bridges, in addition to traditional seismic

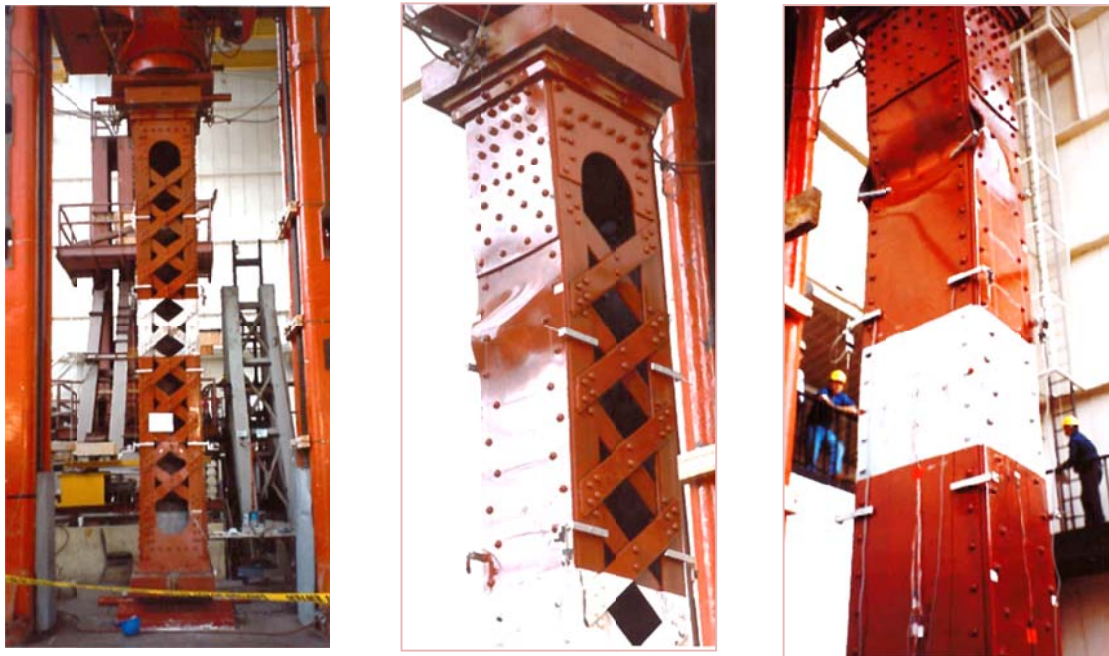
Figure 5: Truss chord specimen and its local buckling during the test [7]

The stiffening truss chord specimen was a 7/8-scale model of a segment of the side span truss from joint to joint as shown in Figure 5. The latticed member specimens were tested with pinned end condition and according to the procedures outlined in the Technical Memorandum No. 4 of the Structural Stability Research Council. After all, instrumentation was installed, calibrated and tested for proper operation, the axial load was applied. The specimens were loaded by a Southwark-Emery 17,800 kN (4,000,000 lb.) hydraulic-based universal testing machine located in the Structural Research Laboratory of the Department of Civil and Environmental Engineering of the University of California at Berkeley. The loading rate was relatively slow; therefore, the tests can be regarded as a static load test.

During the main loading, there were a number of intentional unloadings and reloading at certain load levels to record the elastic unloading behavior of the specimens. The specimens were loaded until buckling occurred and load dropped. The specimens were loaded further after buckling to observe the post-buckling behavior and ductility. The truss chord specimen failed abruptly at 8,675 kN (1,950 kips). This failure initiated by local buckling of the cover plate, Figure 4, at a location of about a quarter of the length from the top. After buckling, the capacity suddenly dropped to about 50% (4,450 kN) of the initial buckling load.

The behavior of specimen indicated that it does not have any ductility and as soon as local buckling occurs in an *elastic* manner, the load suddenly drops. Since there was no economic way to retrofit the truss members to increase their ductility, the seismic retrofit strategy that was followed was to add hydraulic dampers between the main trusses and the tower legs in the longitudinal direction to prevent the development of large axial forces in the truss chords.

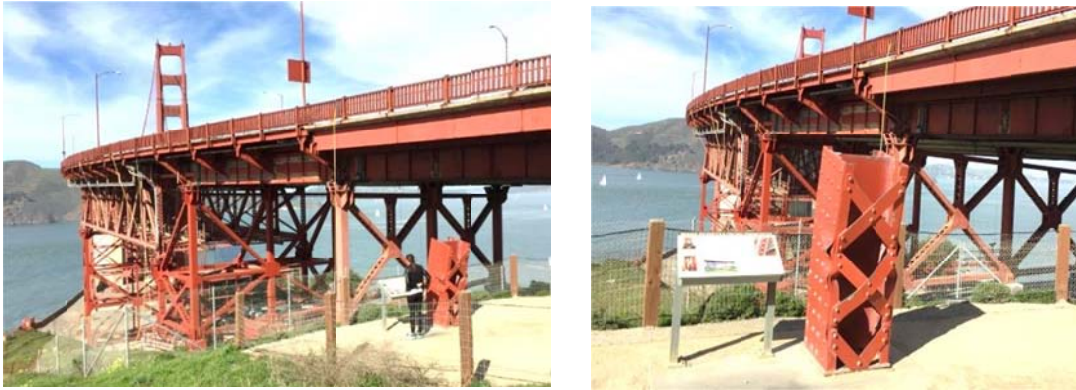
Figure 6: The Golden Gate Bridge specimen tested by Astaneh-Asl et. Al. [7] at the Golden Gate Bridge permanent exhibit site.

Currently, Golden Gate Bridge on its south end has an exhibition area that shows the history of design and construction as well as seismic retrofit. The permanent exhibit has a place to exhibit a piece of the lattice members we tested with a poster board that explains the test program. Figure 6 shows the exhibit area, where our test specimen is exhibited.

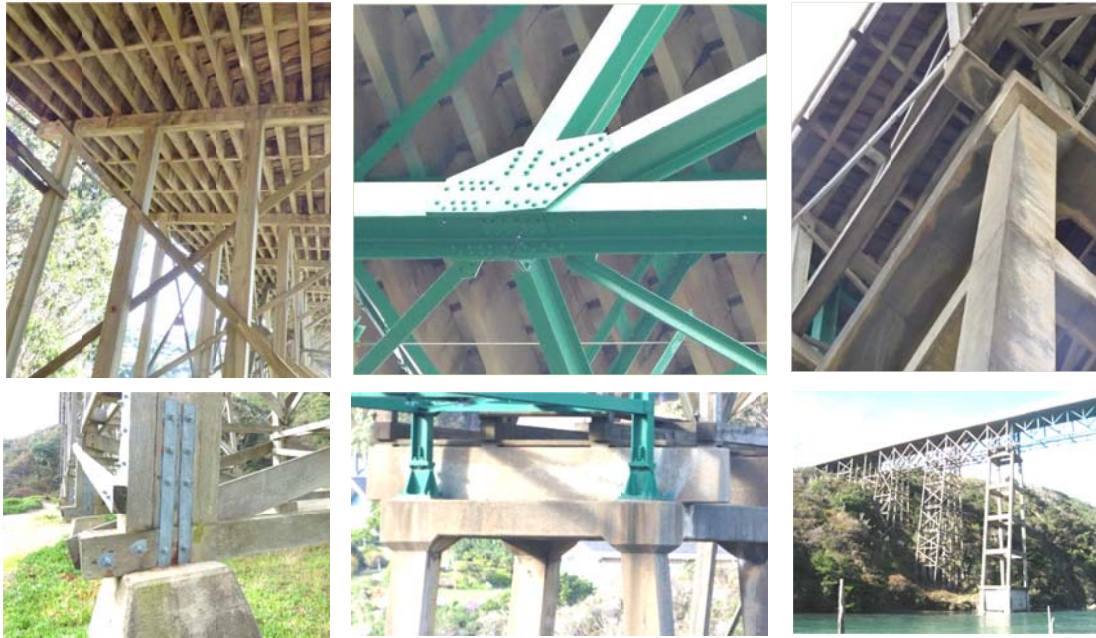
Figure 11: Close-up Views of Typical Timber, Steel and R/C Parts of the Albion River Bridge

The north and south approach spans consist of 11.6 m (38 ft.) span timber trusses supported on ten-legged braced timber towers. The wood trusses and towers are connected using galvanized bolts. The bridge is an excellent historically significant example of a well-preserved, aesthetically pleasing timber bridge. Figures 11 shows typical close-ups of the timber, steel, and concrete elements of the Albion River Bridge. The photos indicate that all components of the bridge are in very good condition. The most recent “Load Rating” report of the bridge indicates that the bridge, after more than 72 years of service, still has the same load carrying capacity that it had when it was built. This is a testimony to the excellent design and proper selection of material as well as good maintenance.

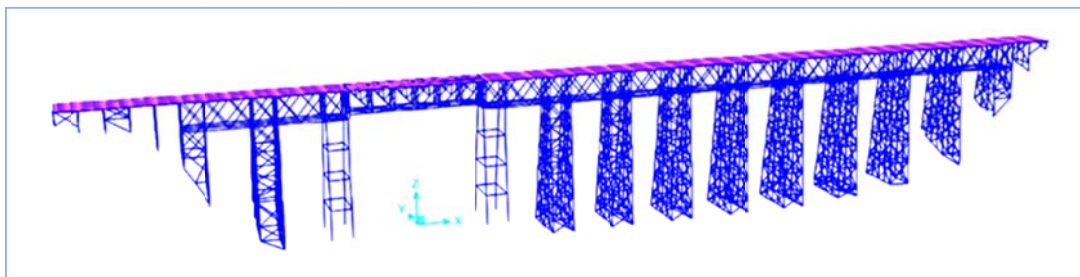
Figure 12: Analysis model of the Albion River Bridge

Figure 12 shows a SAP Model of the Albion River Bridge. Seismic Analysis of the Bridge indicated that there is a need to conduct a thorough investigation of seismic behavior of this

historically significant bridge, at the level of what was done for the Golden Gate Bridge to find out exact seismic retrofit needs of the bridge and to develop proper and economical seismic retrofit to ensure that the bridge survives future earthquakes without noticeable damage to its historical appearance.
