**PRELIMINARY** EXPERT REPORT OF

1 **Executive Summary**

2 The SR 530 Landslide of March 22, 2014 was a tragedy of unparalleled proportions in this country.  
3 Nearly the entire long-term average annual loss of life from landslides in the continental United States  
4 occurred in this one event in the State of Washington for 2014. A few facts are not in question. The  
5 landslide was a deep seated landslide with an elevation difference from crest to toe of just over 600 feet,  
6 and portions of the slide mass traveled to a point just over a mile from the scarp. This report is the first  
7 of what will be a series of reports that will arise out of an effort to fully understand the causes of the  
8 landslide. It is a joint report prepared by an expert team assembled by the Attorney General of the  
9 State of Washington. This joint report is a preliminary document in which we review the hypotheses  
10 either directly listed or implied in the complaints regarding the proximate causes of the SR 530 Landslide

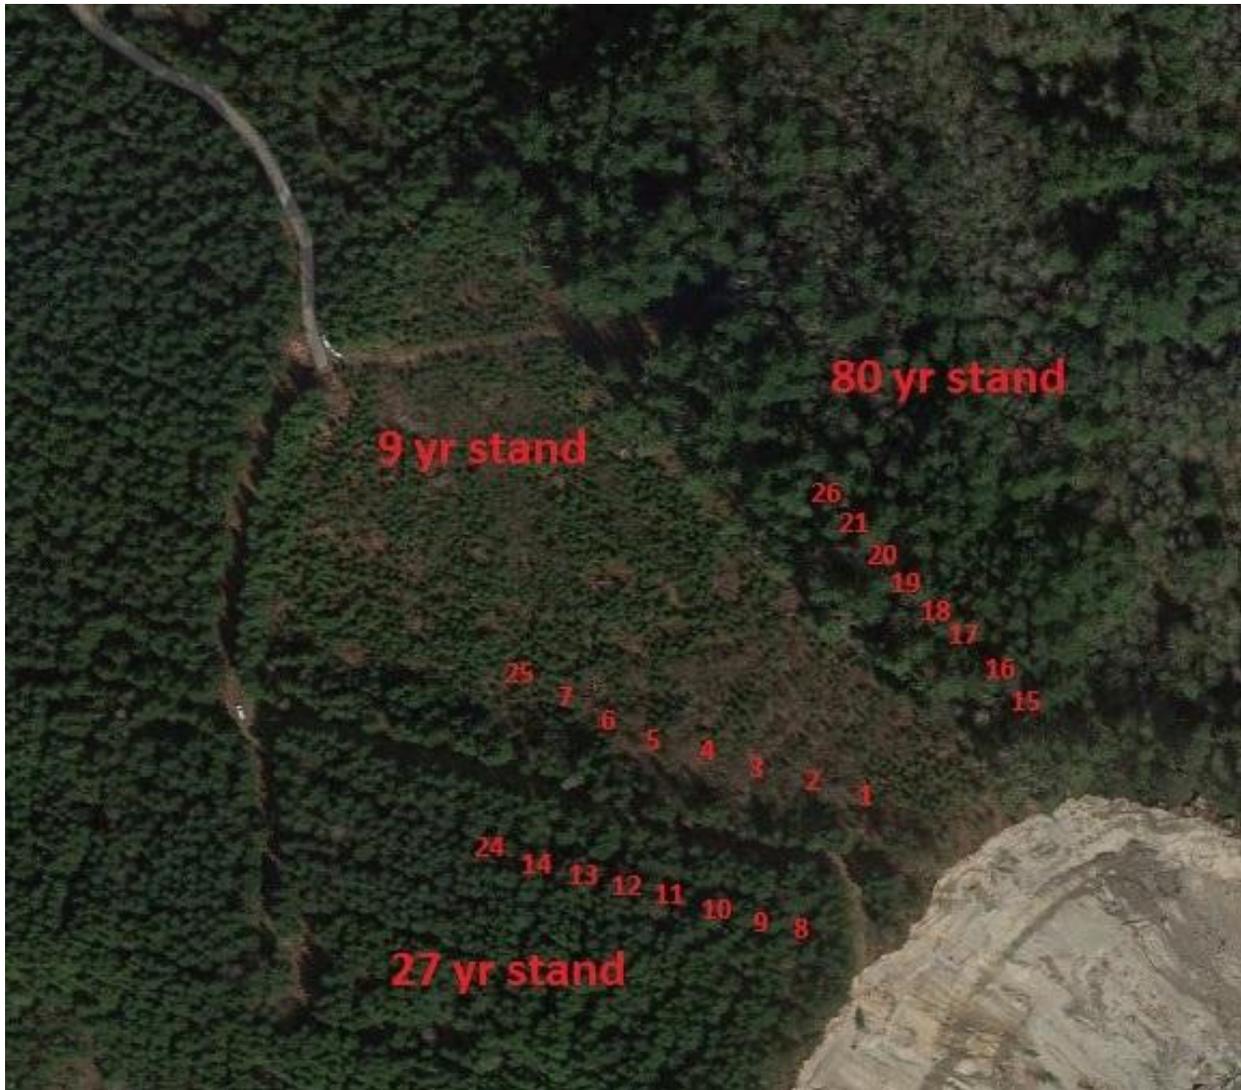
**Figure 2: Overview map of tipping bucket locations.**

14 A network of 26 tipping bucket rain gages were installed in the vicinity of the Oso landslide to quantify  
15 the effect of the different aged forest canopies on precipitation through-fall delivered to the soil surface.  
16 The rain gages are installed in each of the three age classes of forest present in the vicinity of the slide  
17 scarp: 9-year old stand, 27-year old stand, and an 80+ year old stand. The forest in the 27-year old stand  
18 where the rain gages are installed was commercially thinned in 2009-2010. The rain gages are installed  
19 in three transects of eight gages each, in the three different aged forest stands (Figure 2). In addition  
20 there are two rain gages installed in a small clear-cut approximately 1½ miles north of the slide. The rain  
21 gages were installed and data collection began on November 20, 2014 and the last download available  
22 for data reduction is April 14, 2015.

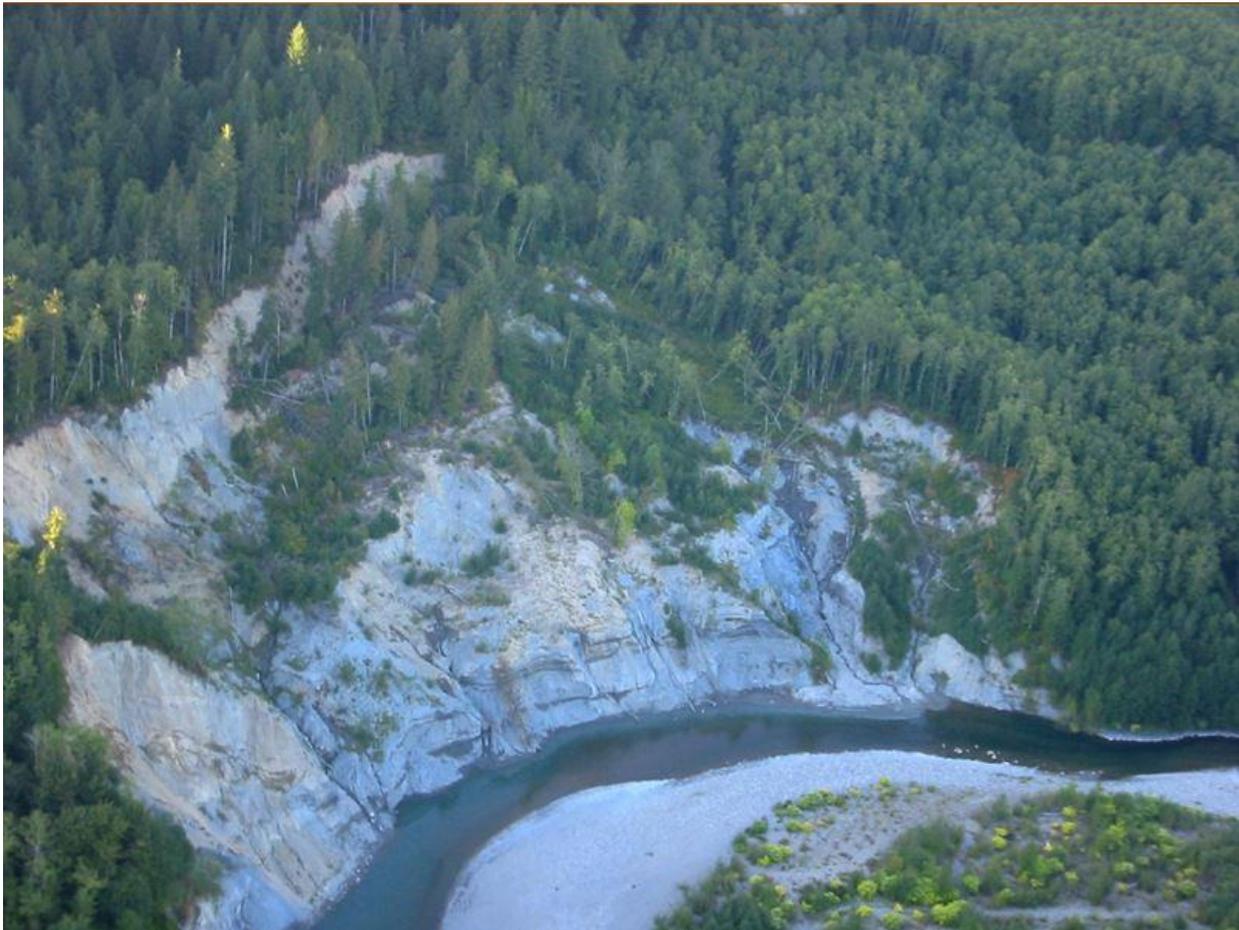
**Figure 9: Aerial oblique image of the Oso Landslide by B. Tart (#4247), taken on September 9, 2002.**

3  
4 During the interim 1947-2014 the river channel migrated significantly, into and away from the slope.  
5 This migration was most noticeable around 1969 and again, in early 2006. An aerial oblique photo taken  
6 in September 2002 (Figure 10) suggests that the basal slip surface at that time was well above the  
7 Olympia-age (33 ka) older alluvial unit exposed along the right channel bank, and that the basal rupture  
8 surface appears to be up in the lower fifth of the Vashon advance glacial lake deposits, comprised chiefly  
9 of over-consolidated clay and silt. Figure 9 is purported to show that the basal slip surface of the slide  
10 flooded in the lacustrine clay above the exposed beds of pre-glacial Olympia beds seen here, forming the  
11 bluffs along the right bank of the river channel.

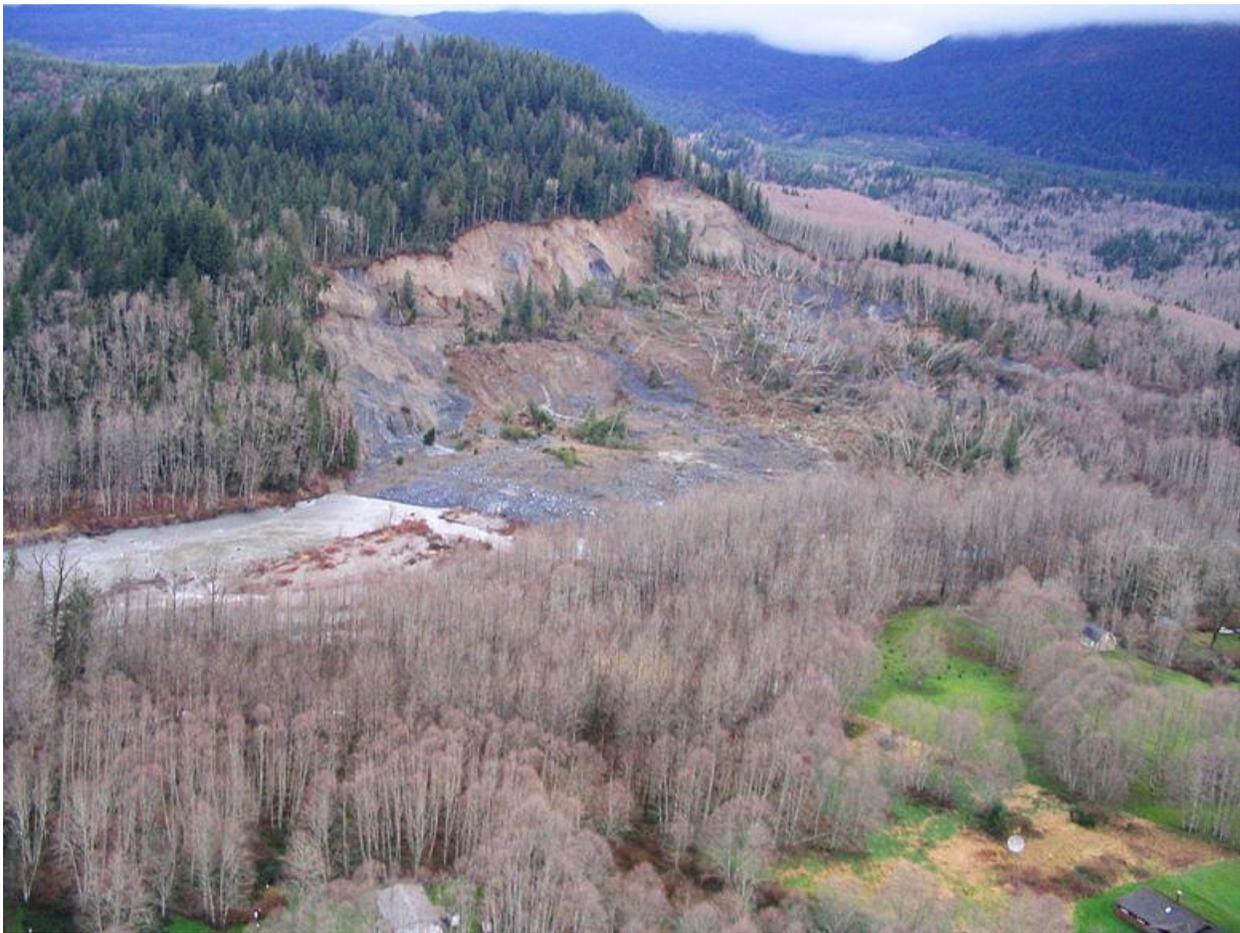
11 **Figure 10: Aerial oblique view of January 2006 slide (7).**

1 The January 2006 slide, shown in Figure 10 and Figure 11, appears to have involved more material than  
2 previous events. The toe of this slide also appears to have fluidized where the debris filled the river  
3 channel and displaced it southward, about 300 feet. Note the slope of the flowing toe, which is not flat,  
4 but gently sloping at what appears to be between 4 and 11 degrees (see Figure 11), not typical of  
5 liquefaction or lateral spreading. That fluidization was assumed to be something of an aberration at the  
6 time because of all the water absorbed by the debris entering the river. At that time, most geologists  
7 and geotechnical engineers in Washington also assumed that clayey landslides had little potential for  
8 liquefaction.

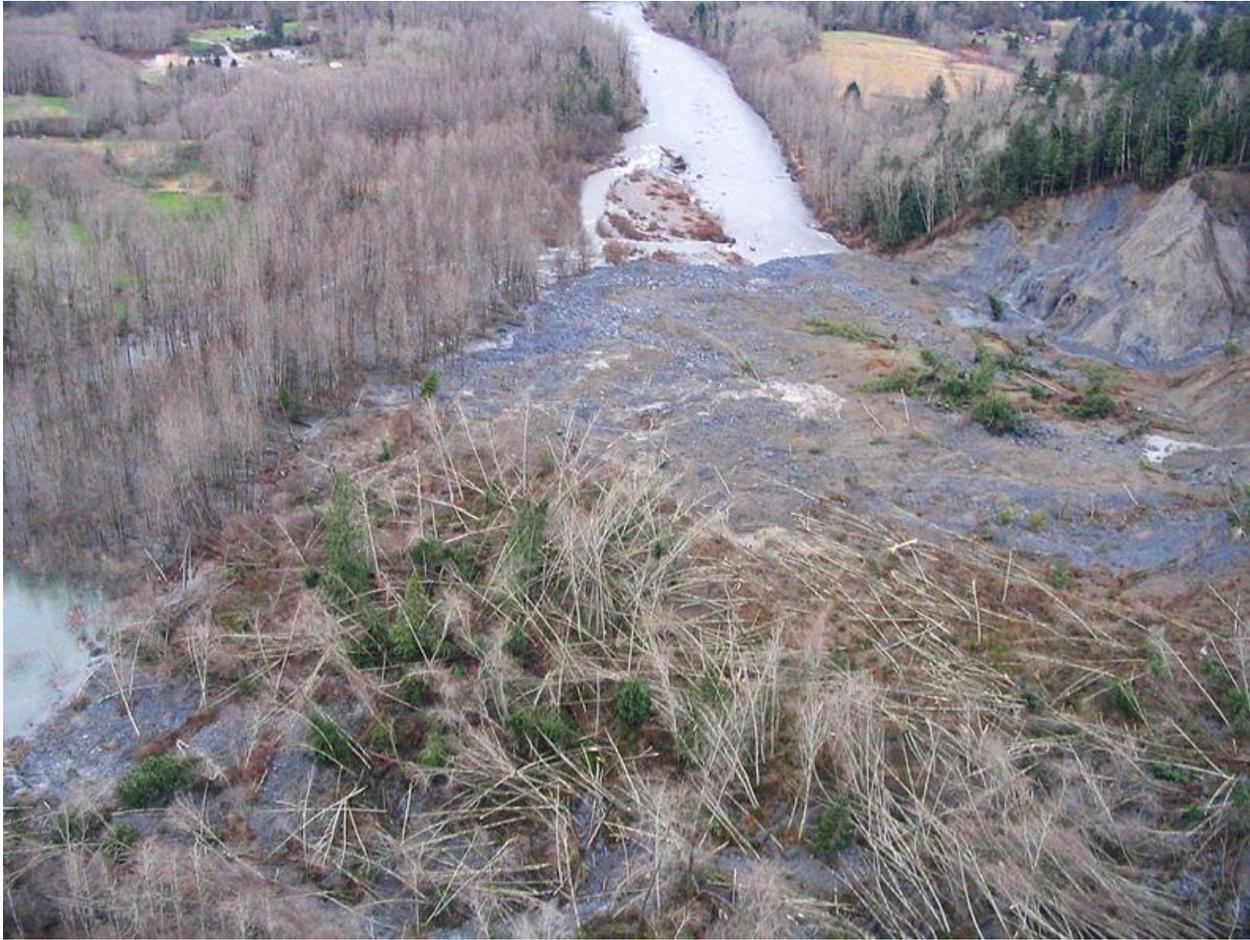
2 **Figure 11: Slope of flowing toe from 2006 event (7).**

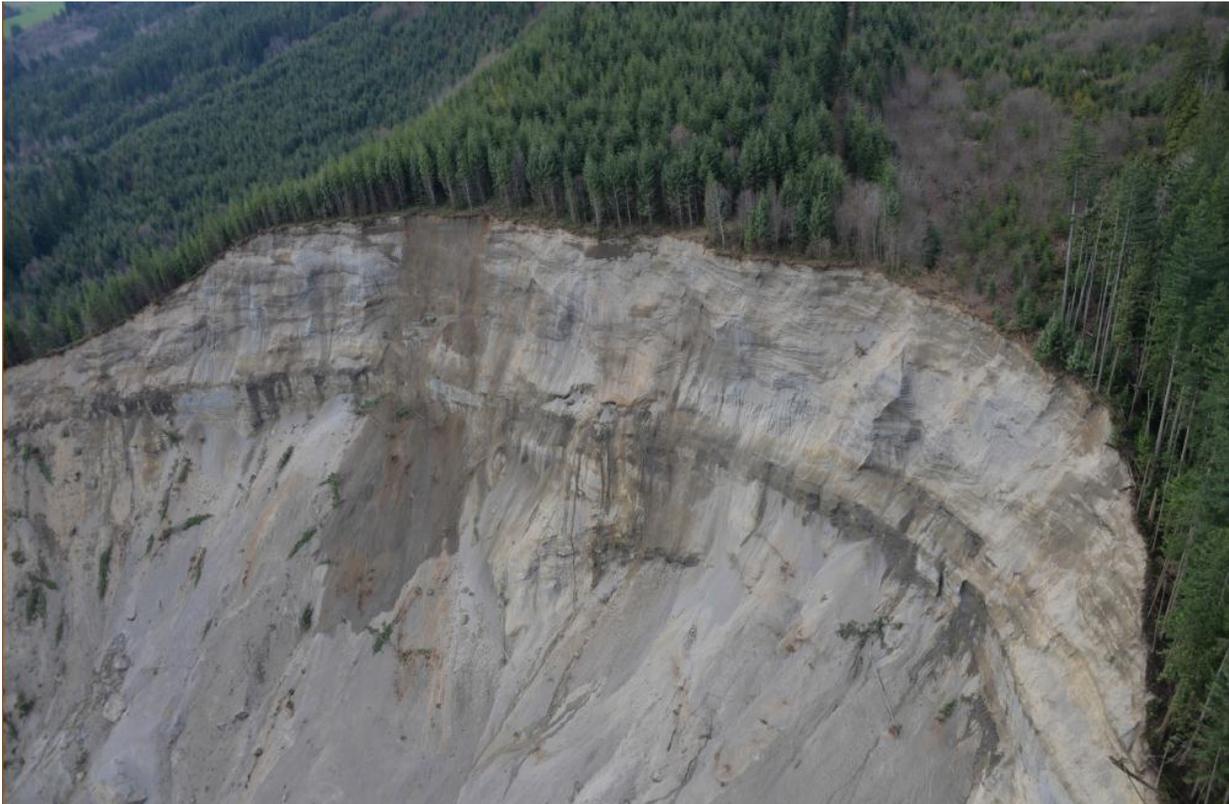
Figure 13: Head scarp evacuation scar of the March 22, 2014 Oso Landslide (8).

1 Figure 13 is an aerial oblique view of the head scarp evacuation scar of the March 22, 2014 SR 530  
2 Landslide, taken two days after it occurred. A massive sequence of cohesionless gravels and sands  
3 were exposed, which rapidly receded over the following weeks. The Vashon Till is likely described by the  
4 dark lines of increased moisture and spotty seepage.

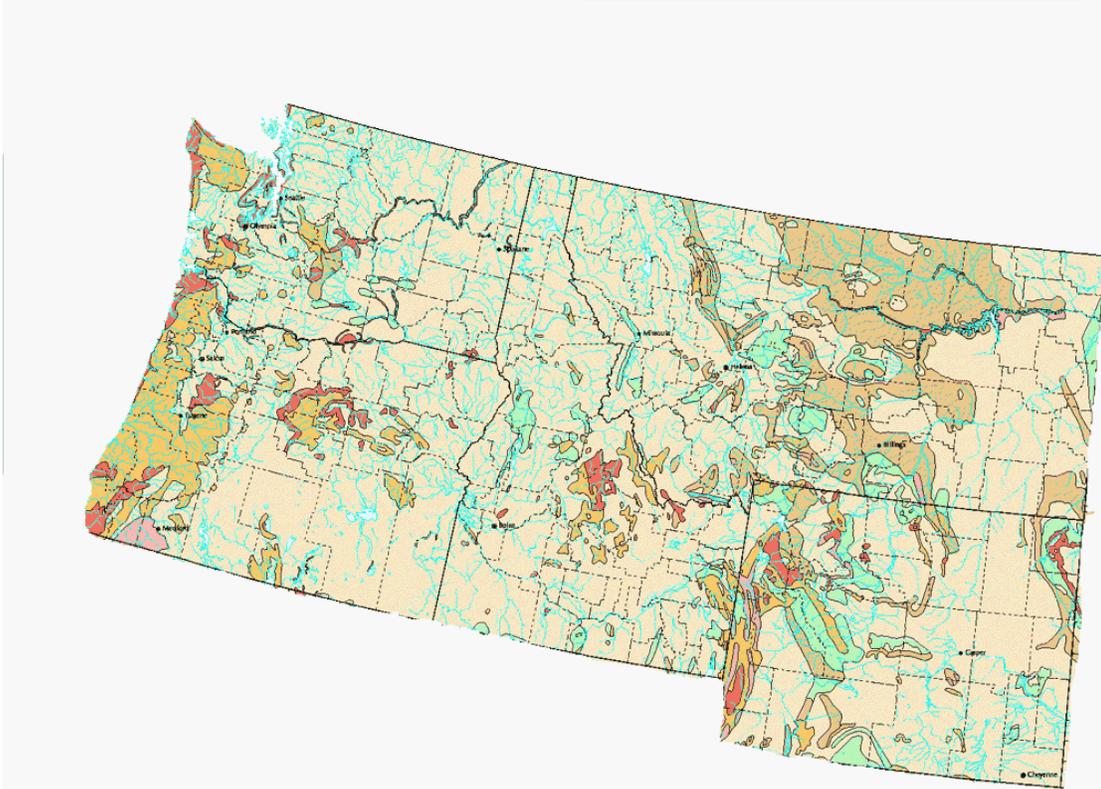
**Figure 19: “Landslide Overview Map of the Conterminous United States Legend” (17).**

How can this be correct? The answer is a combination of scale, the objectives of the work, and the historic record that was used to develop the map. Low incidence in this case indicates less than 1.5% of the land area is involved in landslides.

22 Scale is a very important parameter in assessing landslide hazard. We have included  
23 below (Figure 19), the Pacific-Northwest a sector of the map, “Landslide Overview Map  
24 of the Conterminous United States Legend” by Radbruch-Hall, et.al. (17). This map  
25 shows areas of landslide susceptibility based on the characteristic response of geologic  
26 formations and soils to natural or artificial cutting or loading of slopes, or to  
27 anomalously high precipitation. Note that the area around Oso, Washington is shown in  
28 base color which indicates low landslide incidence.
