SUPERIOR COURT OF WASHINGTON FOR KING COUNTY

INTERIM EXPERT REPORT OF

JANUARY 22, 2016

2 The State Route (SR) 530 Landslide of March 22, 2014 was a slope failure of unparalleled proportions in
3 this country. This volume comprises the second joint report in what will be a series of reports that
4 chronicle the progress of the expert team assembled by the Attorney General (AG) of Washington in an
5 effort to fully understand the causes of the landslide. This report must be considered a preliminary
6 document, because, in the opinion of the authors, there is insufficient site-specific factual information
7 available at the present time to offer an informed opinion on some of the hypotheses regarding the
8 proximate causes of the SR 530 Landslide of March 22, 2014. More substantial forensic opinions will
9 emerge after completion of the geotechnical field exploration program, geotechnical laboratory testing,
10 and engineering analyses. To date, only the geotechnical field exploration has been largely completed.

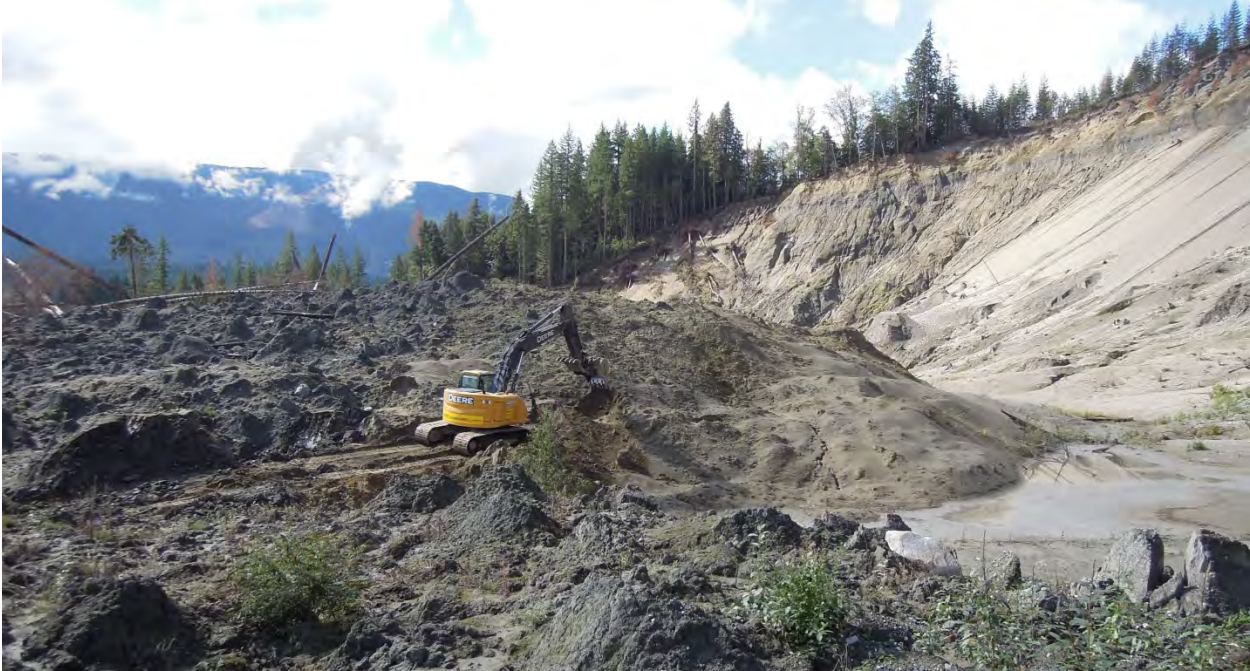
1
2 *Figure 5: Tracked excavator grading an access path to the drill pad for EB-04 on the main body of SR 530 Landslide.*
3

14
15 Developing access to the main body of the SR 530 Landslide required significantly more effort, and the
16 preparation and submission of a grading permit to Snohomish County and DNR to enable the
17 construction of temporary access paths to the exploration points (the permit was submitted in mid-
18 August 2015 by WSDOT). A separate, much shorter, access route was identified from the east, using C-
19 Post Road, traversing private property to a staging area just east of Rollins Creek. This location, however,
20 required negotiation of an access agreement with the private landowners, construction of a temporary
21 crossing of Rollins Creek (Figure 4) and grading of an access route, so that the drill equipment could
22 reach the proposed boring locations (Figure 5).

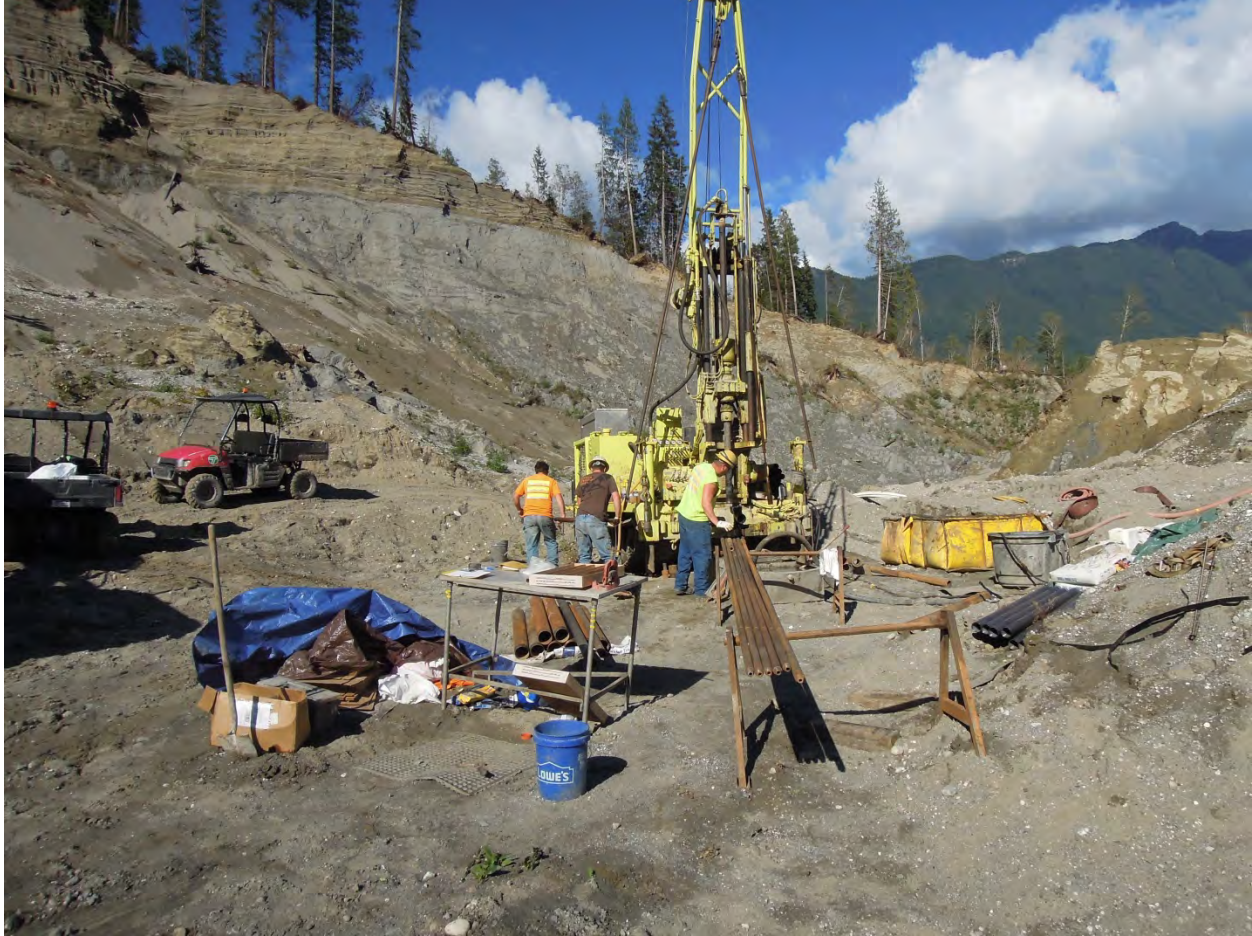
1
2 *Figure 6: CME-850 drill rig setup at EB-04 on the main body of SR 530 Landslide (drill rods supported on stands).*
3

5 The exploratory borings on the SR 530 Landslide were advanced using a CME-850 tracked drill rig (Figure
6 6). Two drilling techniques were used; hollow stem auger and rotary wash. The hollow stem auger
7 technique was used in the Recessional Outwash sands so that soil samples could be obtained and
8 moisture content testing performed, to ascertain representative values of in-situ soil moisture content
9 (rotary wash methods typically saturate sandy materials during the drilling/sampling process). Hollow
10 stem auger drilling was employed on EB-01vwp-15 and SP-01vwp-15. The remaining borings were
11 advanced using rotary wash methods.

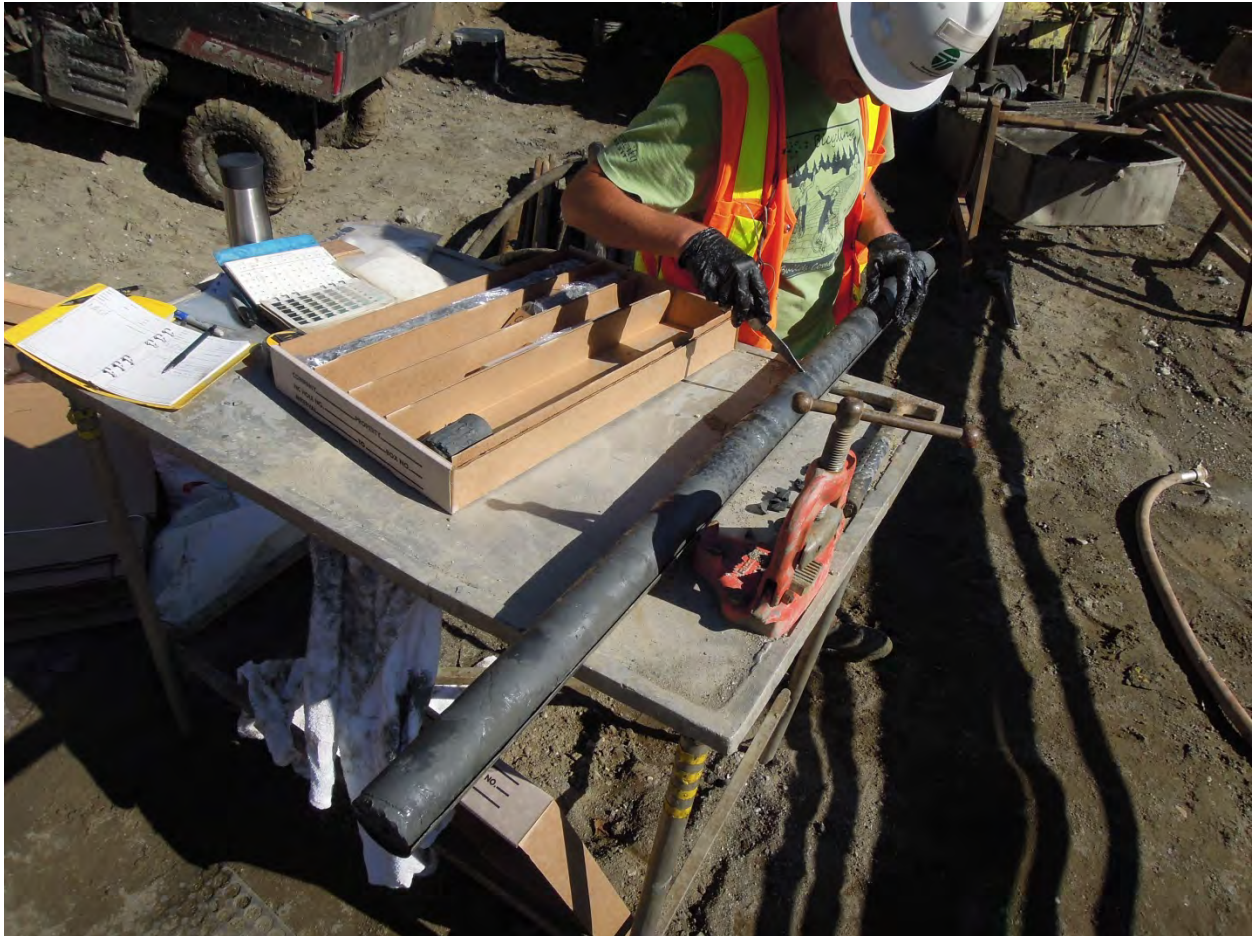
1
2 *Figure 7: WSDOT Inspector examining soil core sample and packaging in core box.*
3

12
13 WSDOT provided the drill rigs and support crews. Each drill crew typically included an inspector who
14 would log the stratigraphic units encountered and catalog the collected samples.
15

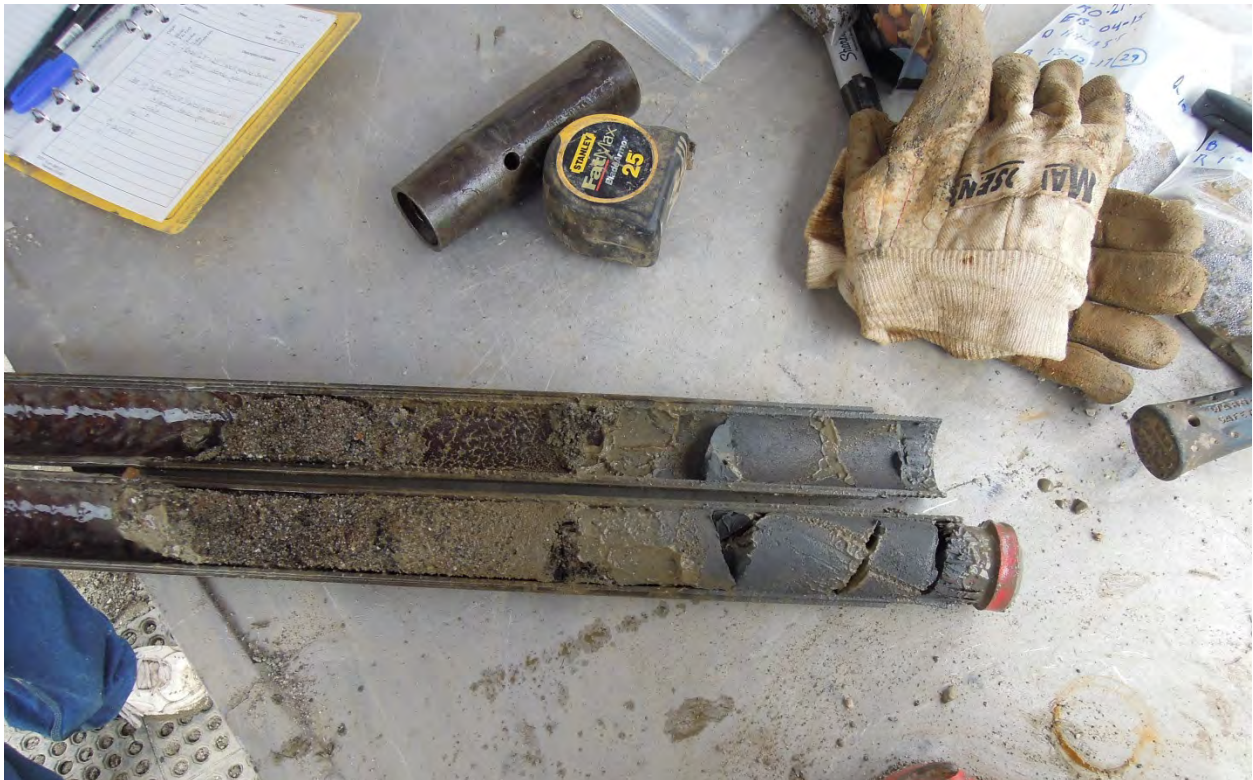
12
13 *Figure 8: Surface of rupture delineated at contact of recessional sand and glacio-lacustrine silt and clay at boring*
14 *EB-04-si-15.*

10
11 The surface of rupture was found exposed in the lower western portion of the slide source area, and
12 was found in the borings installed in the slide area. In some of the borings, identification of the location
13 of the surface was unequivocal, as the surface represented the transition from high stratigraphic units
14 (recessional outwash) into much lower stratigraphic units (glacio-lacustrine silt and clay), as shown in
15 Figure 8. In other borings, the determination was made on the basis of an abrupt transition from
16 disturbed/distorted laminae in the fine-grained glacio-lacustrine units to horizontally laminated material.

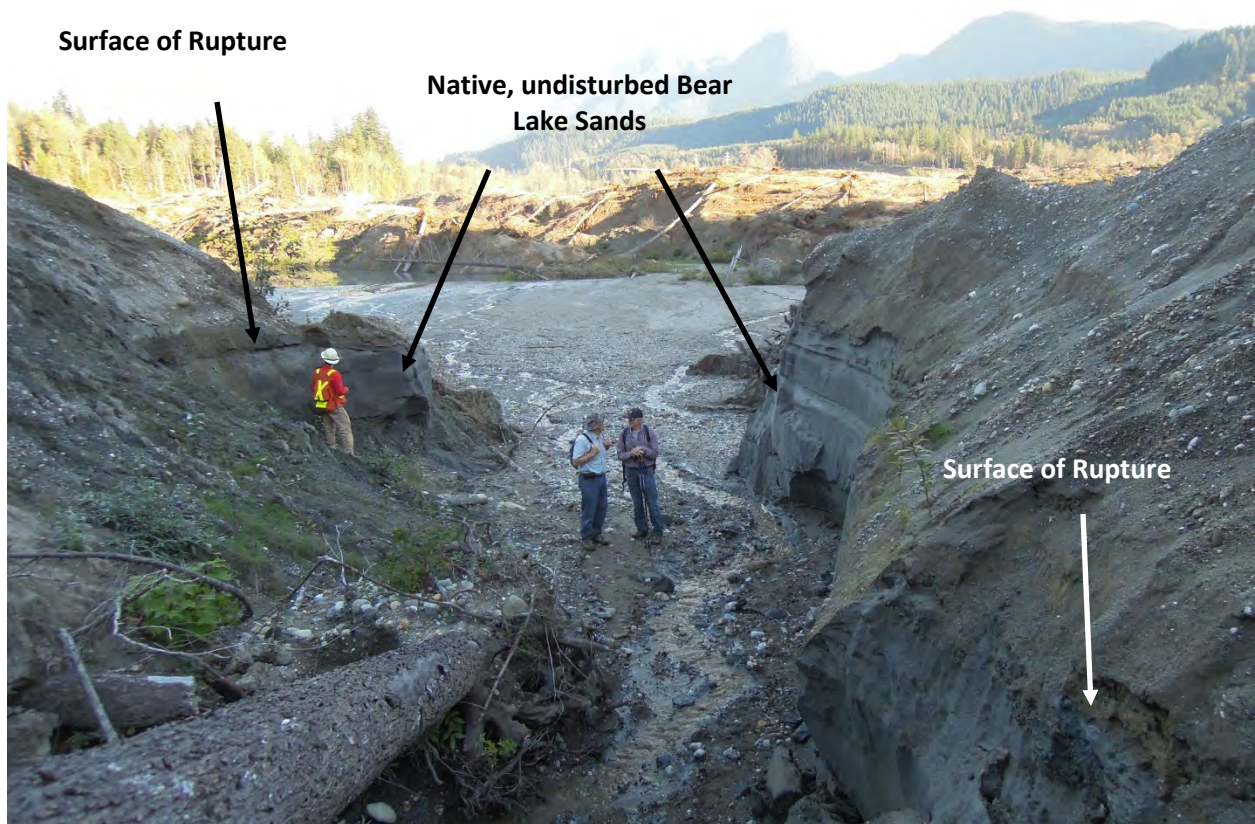
1
 2 *Figure 9: View of surface of rupture exposure with clay shear zone at top of Bear Lake Sands (photo taken on*
 3 *10/23/2015 at 48.282N;121.848W, looking SW).*
 4

4
5 In the exposures in the lower western source area (Figure 9 & Figure 10), the surface of rupture is
6 located on and barely within the Bear Lake Sand, transitioning upslope into the lowermost portion of
7 the glacio-lacustrine silt and clay. In some exposures of the SR 530 Slide Surface of Rupture, Recessional
8 Outwash is found on undisturbed Bear Lake Sands or on horizontally laminated fine-grained glacio-
9 lacustrine unit. At other exposures, other stratigraphic units are found in contact with the Bear Lake
10 Sands. These exposures are also all located above El. +310 feet.

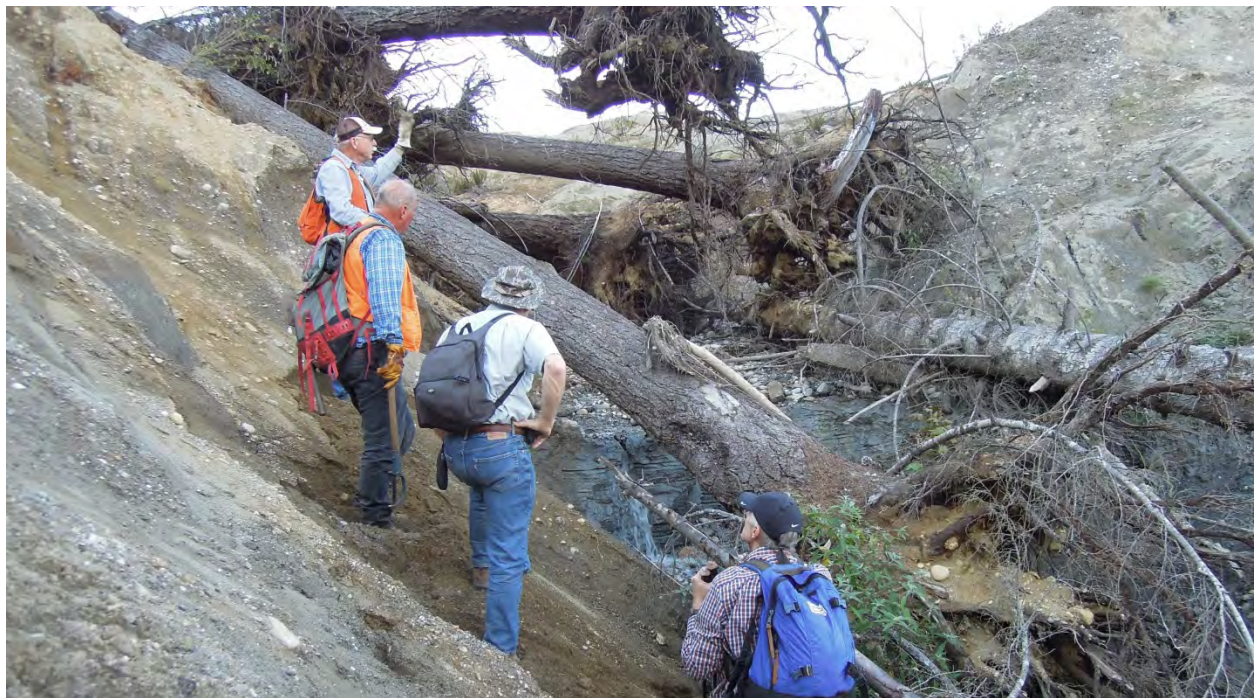
5
 6 *Figure 10: View of glacio-lacustrine silt and clay exposure of surface of rupture (photo taken 10/23/2015 at*
 7 *48.282N; 121.848W, looking N).*

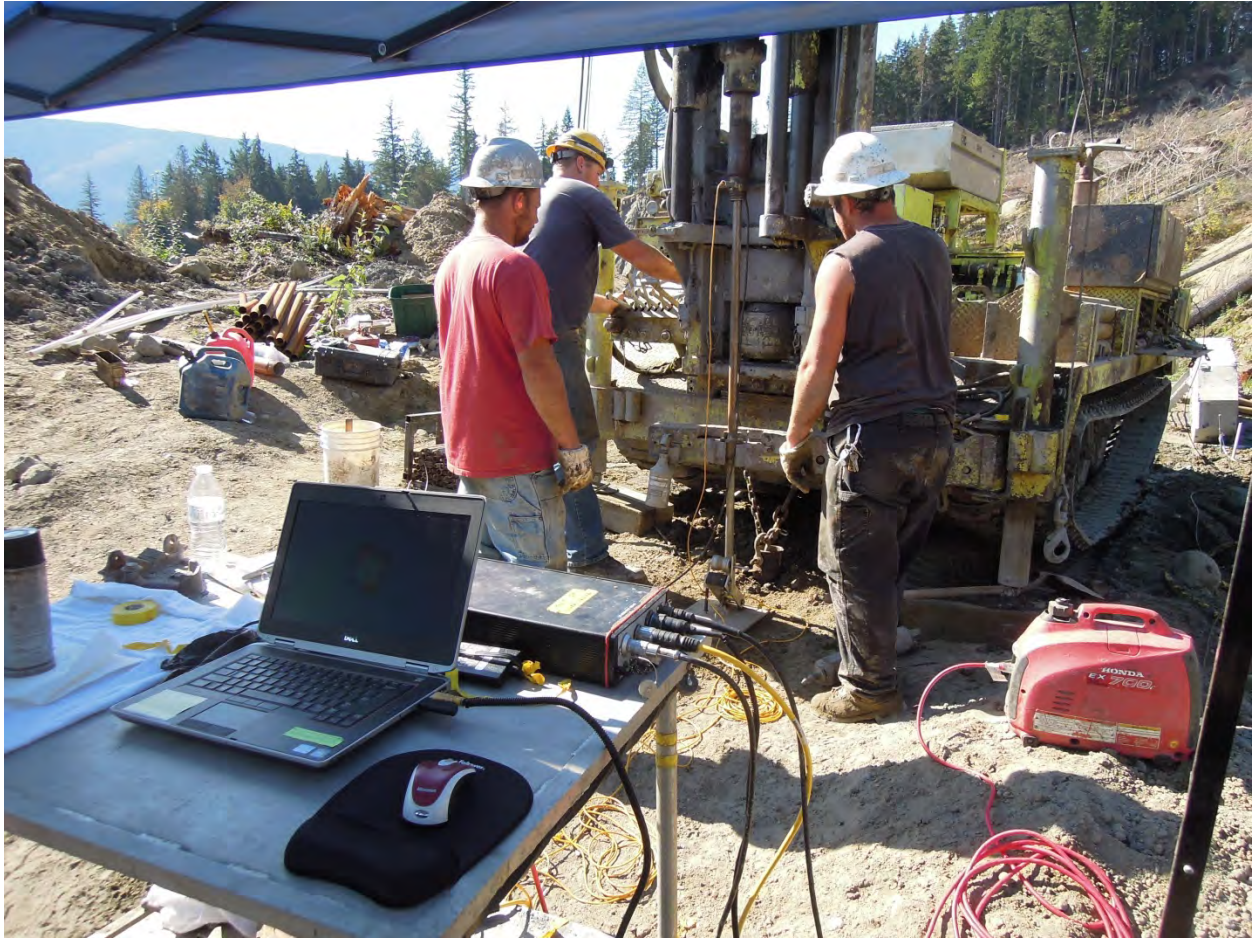
Figure 11: Pushing CPT with the CME-850 at the EB-12 exploratory location.

4 Cone Penetration Tests (CPTs) were attempted at four of the exploratory borings locations: EB-01, EB-04,
 5 EB-09, and EB-12. The CPT was advanced using the CME-850 rig (Figure 11). The CPT crew experienced
 6 significant challenges advancing the CPT at the EB-01 location. The drilling crews were able to advance
 7 the CPT with a series of push-drill-push sequences at EB-04, EB-09, and EB-12. The reported CPT results
 8 are presented in Appendix C.

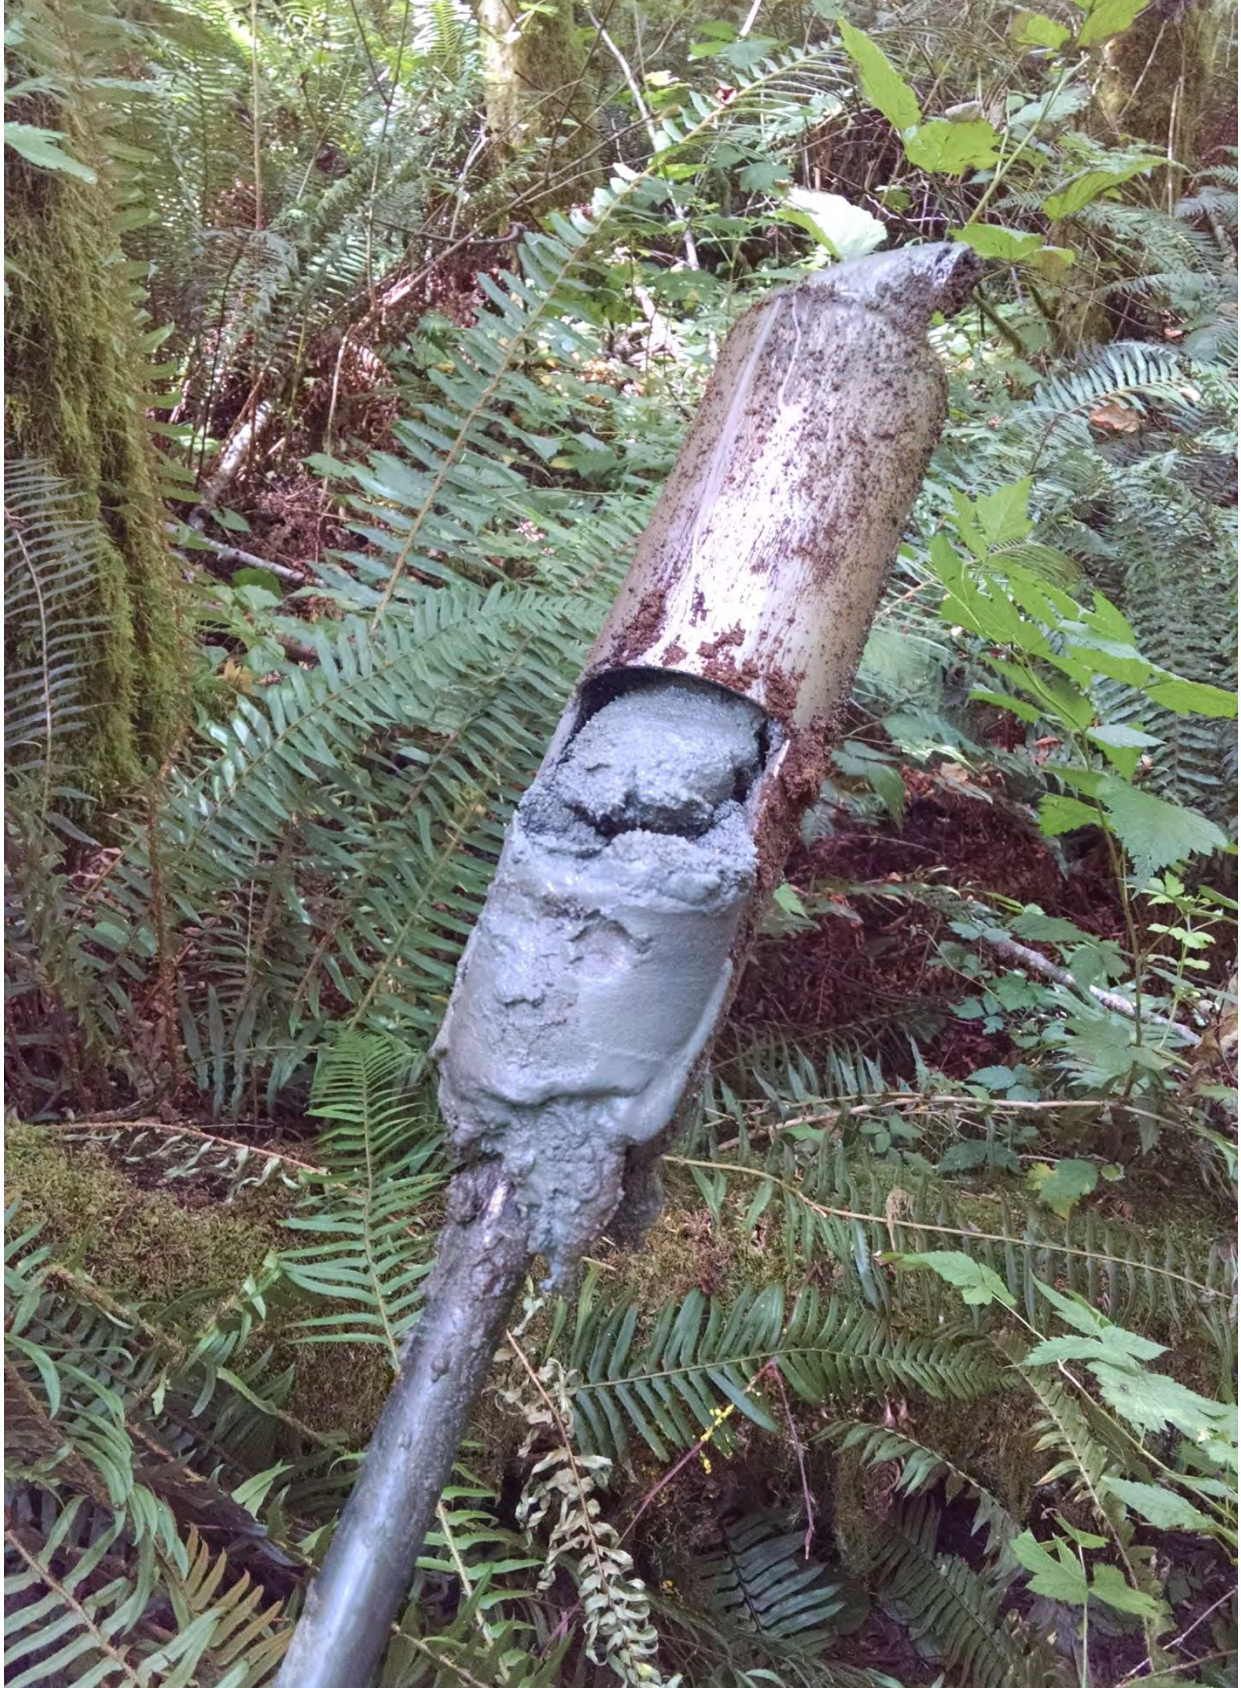
Figure 14: Hand auger within Headache Creek encountered sandy clay (location #2 in Figure 12).

1 Within the Headache Creek Basin, we performed seven shallow (3-15 feet) hand auger probes to
2 examine the surficial soils. These borings encountered olive-gray clayey sand to sandy clay, until we hit
3 refusal due to the presence of gravels/cobbles (Figure 14). The hand auger probes on the ridge between
4 Headache Creek Basin and the Hazel Landslide encountered material consisting of well graded sand to
5 silty sand. "Blue" sandy clay was encountered at a depth of 14 feet at the ridge location. Water was
6 also encountered at a depth of 14 feet (on 9/27/15).

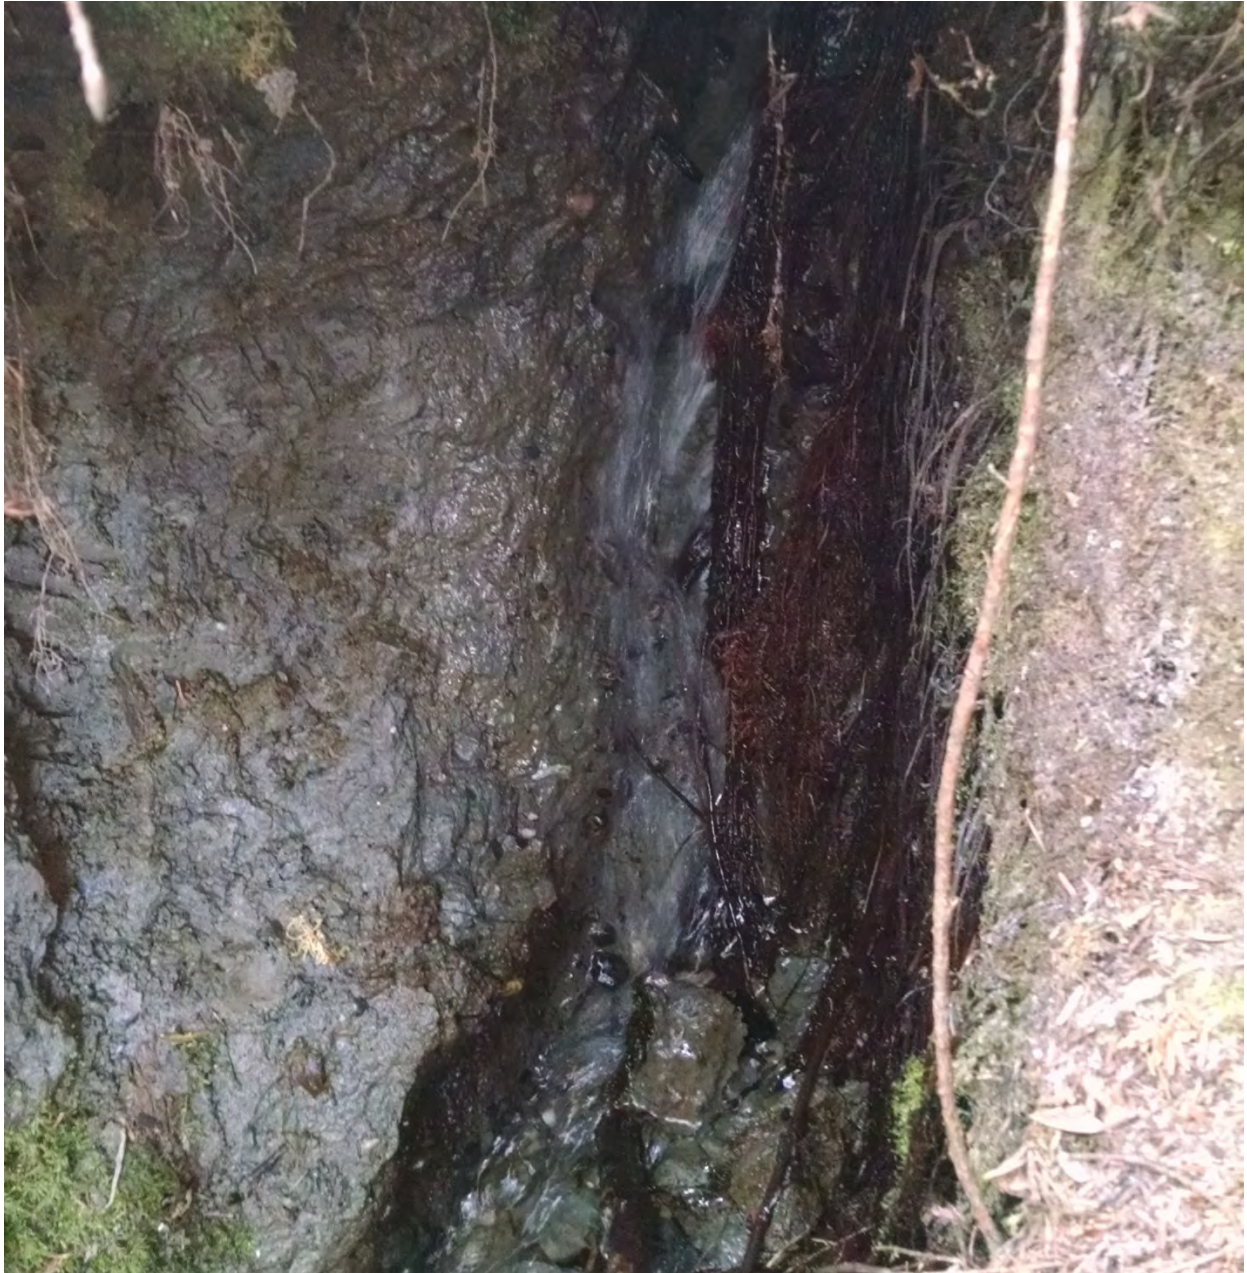
6
7 *Figure 15 Spring emanating from Whitman Bench (~10 gal/min) (location #3 in Figure 12).*

1 We mapped several seeps and springs (Figure 15) along the western margin of Headache Creek Basin.
2 We observed that approximately 1/3 of the Upper Headache Creek Basin drains to the north; the other
3 2/3 drains down to Rollins Creek via Headache Creek. We were unable to locate any similar discharges
4 within the main scarp of the SR 530 Landslide.
5

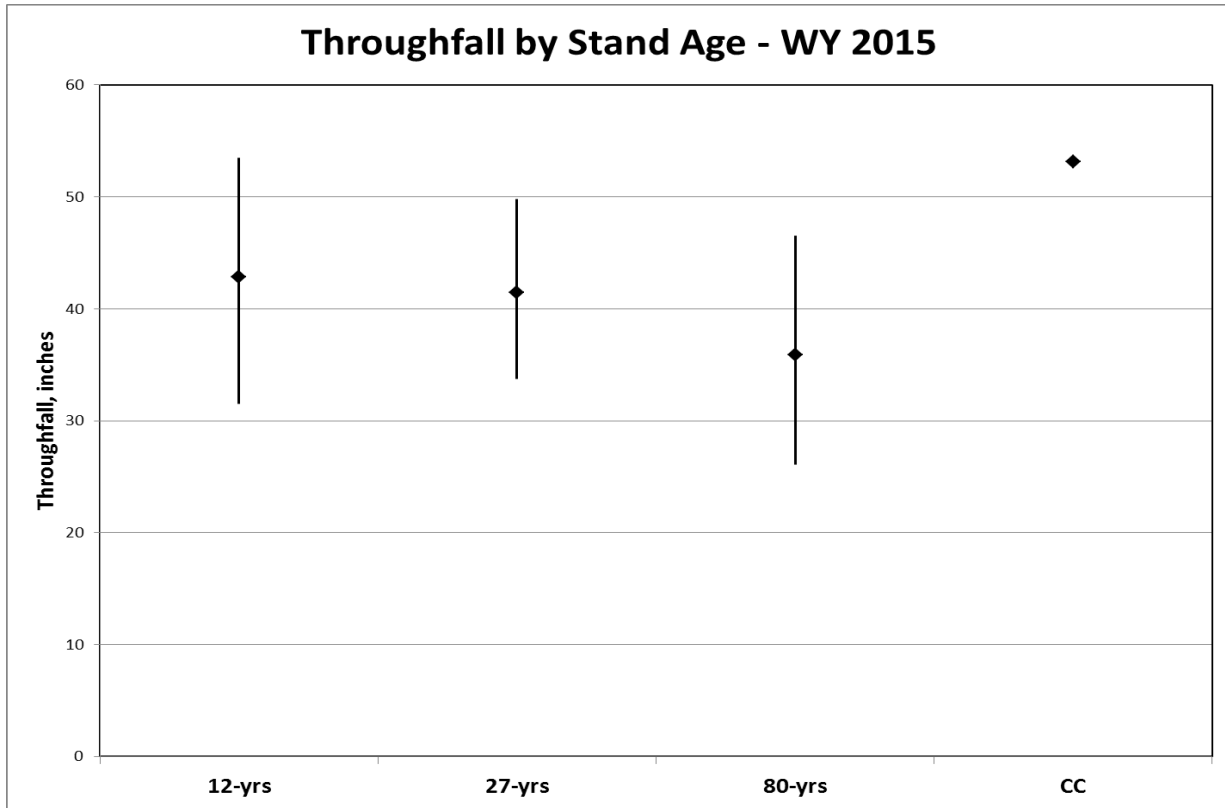
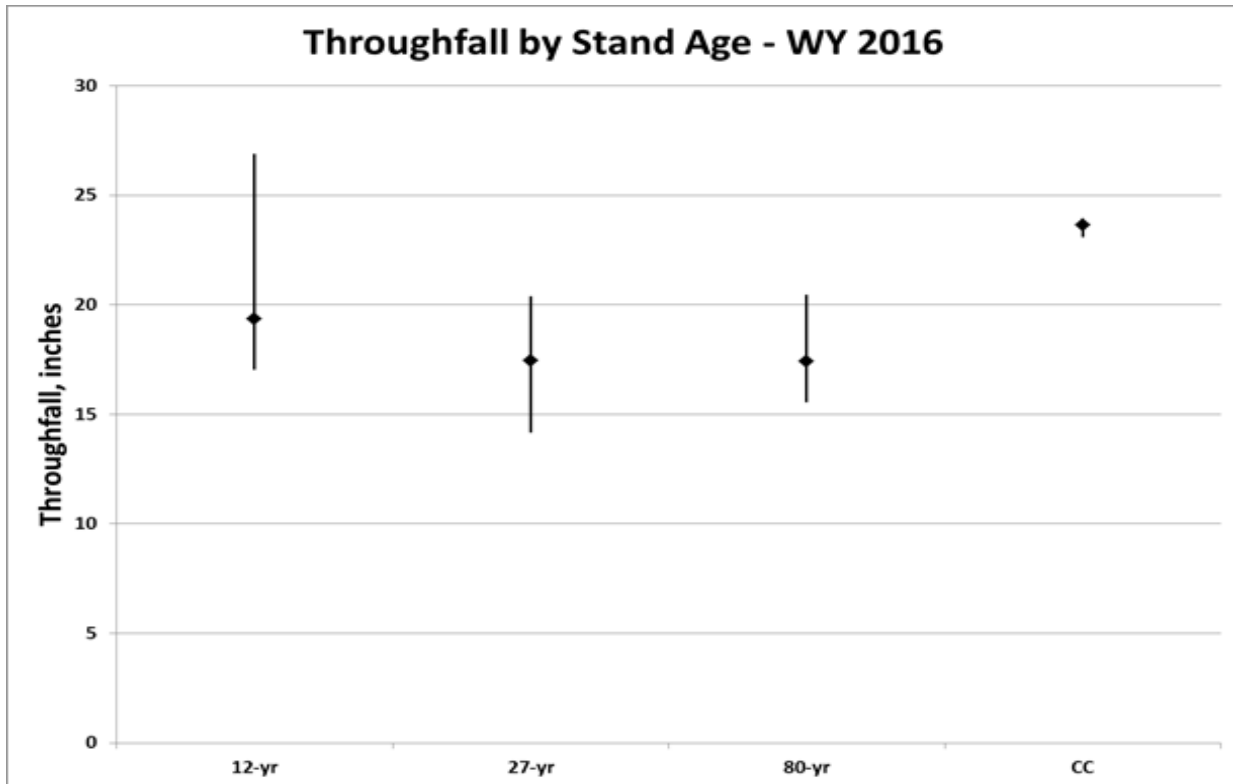
1
2
3
Figure 21: Summary of precipitation throughfall results for water year 2015.

4
5
Figure 22: Summary of precipitation throughfall results for water year 2016 (through 12/5/2016).

1
 2 The average and the range of throughfall measured for each of the different aged forest stands and the
 3 clear-cut are summarized in Table 3 and depicted in Figure 21 and Figure 22. The clear-cut, as expected,
 4 has recorded the most rainfall. The different age classes of forest all received roughly the same amount
 5 of throughfall. The throughfall for the 12- and 27-year old stands are essentially the same. The
 6 throughfall for the 80+ year old stand is numerically less than the other two stands. The trend in
 7 throughfall exhibited in water year (WY) 2015 has continued in WY 2016.

8
 9 The throughfall values calculated for the different age forest stands are averages gleaned from the rain
 10 gages in each stand. There is high variability among the throughfall values for each stand. There is less
 11 variability in the clear-cut. The variability is represented by the range of the throughfall values for each
 12 age stand listed in the table and illustrated in the graph. There was missing data for each of the two rain
 13 gages in the clear-cut in WY 2015, thus a range cannot be calculated. A range of values was available for
 14 WY 2016.
